CONNECTICUT RIVER BASIN  
ATHOL MASSACHUSETTS

ATHOL MANUFACTURING  
DAM  
MA 00932

PHASE I INSPECTION REPORT  
NATIONAL DAM INSPECTION PROGRAM

MARCH 1979

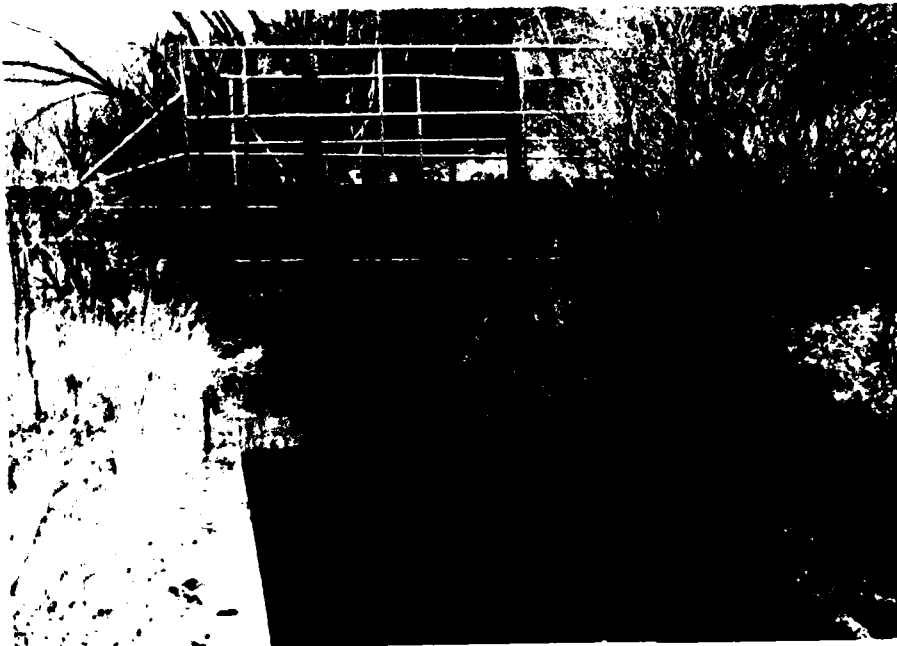
PHOTO NO. 10 - Downstream view of outlet sluice gate and service walkway. Facility is used in power generation.
